**RE: Remedial Action Completion Report, Landfarm Remedy
Prewitt Refinery Superfund Site
Unilateral Administrative Order, Docket Number 6-17-93**

REMEDIAL ACTION CONSTRUCTION AND COMPLETION REPORT

LANDFARM REMEDY

**Prewitt Refinery Site
Prewitt, NM**

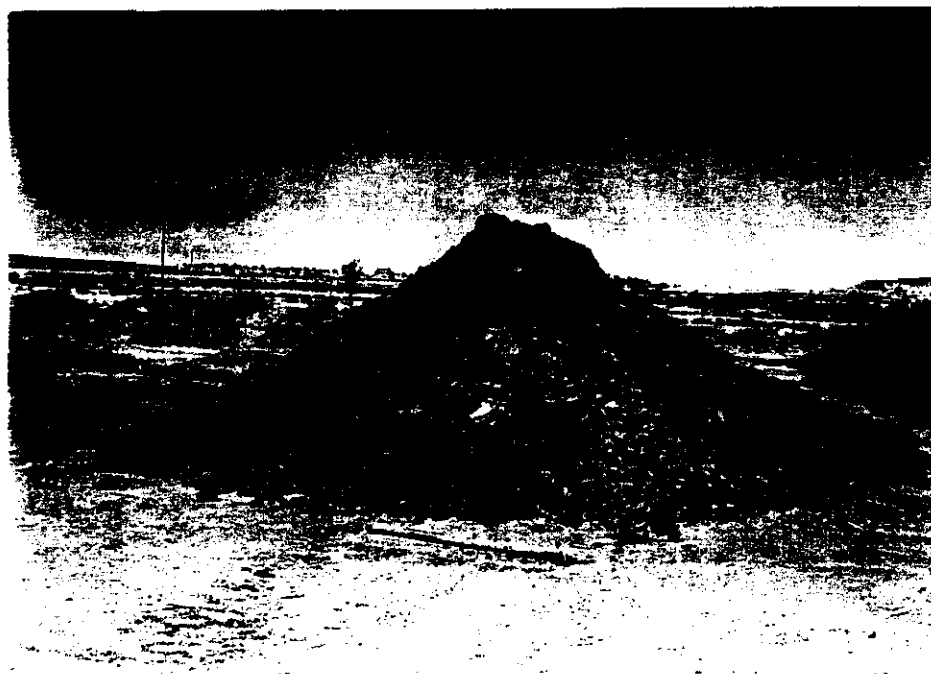
Photo 3-2. Temporary Stockpile of Hydrocarbon Soils Removed During Landfarm Construction

The soil mound and hydrocarbon stained soils, encountered during excavation for subgrade preparation (Photo 3-1), were also segregated and temporarily stockpiled near the West Pits for placement in the landfarm for treatment as shown in Photo 3-2. This soil volume was approximately 125 cubic yards. Confirmatory sampling of the excavation following removal of the hydrocarbon-contaminated soil from the landfarm was not performed for the following reasons:

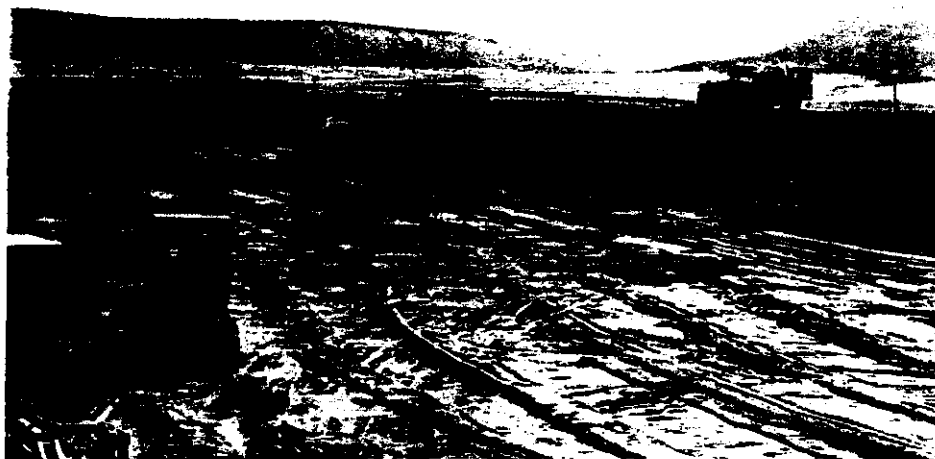
Photo 3-3. Temporary Stockpiling of Soils Excavated During Landfarm Subgrade Construction

Concrete, old refinery piping, and oil stained soils were also encountered when preparing the surface immediately east of the landfarm for the temporary soil stockpile (Photo 3-4). Since the RA sequence was to construct the landfarm first and then to remove hydrocarbon soil, the soils removed during subgrade preparation were stockpiled in an adjacent location and the oil-stained soil and piping was scheduled for removal during hydrocarbon soil excavation work.

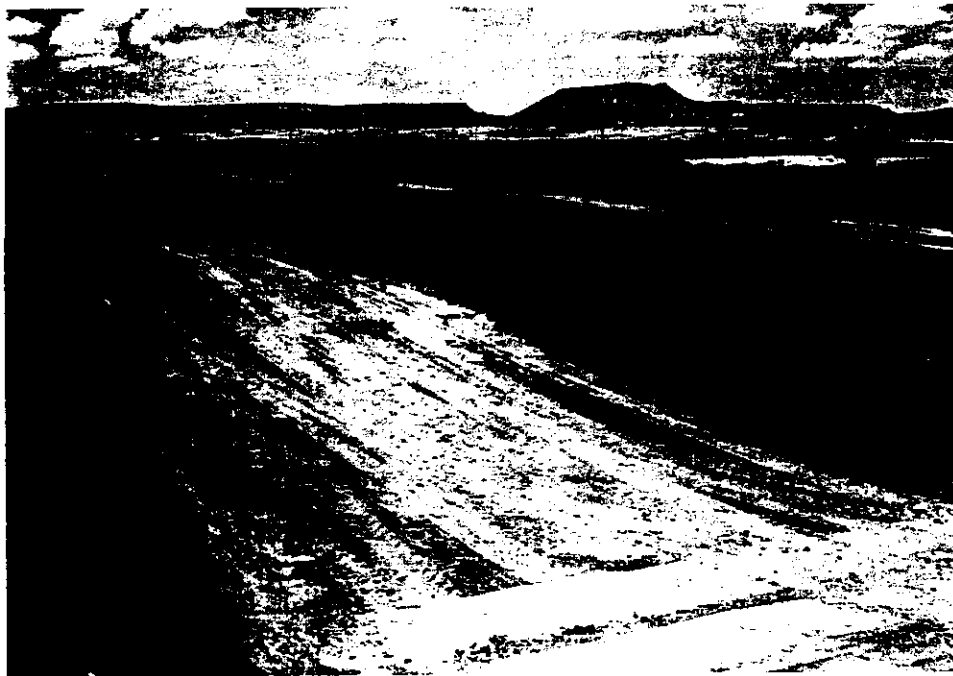
Photo 3-6. Dozing Clay Layer During Construction of the Liner

The liner was constructed in accordance with the RD. The clay was brought in by truck and spread out in a 9-inch lift with dozers as shown in Photo 3-6. Water was applied and the clay soil disked during placement in the landfarm as shown in the photograph in Photo 3-7 in order to achieve optimum moisture for compaction. The clay liner was compacted using dozers and a sheeps foot roller. Water was applied continuously during compaction of the clay.

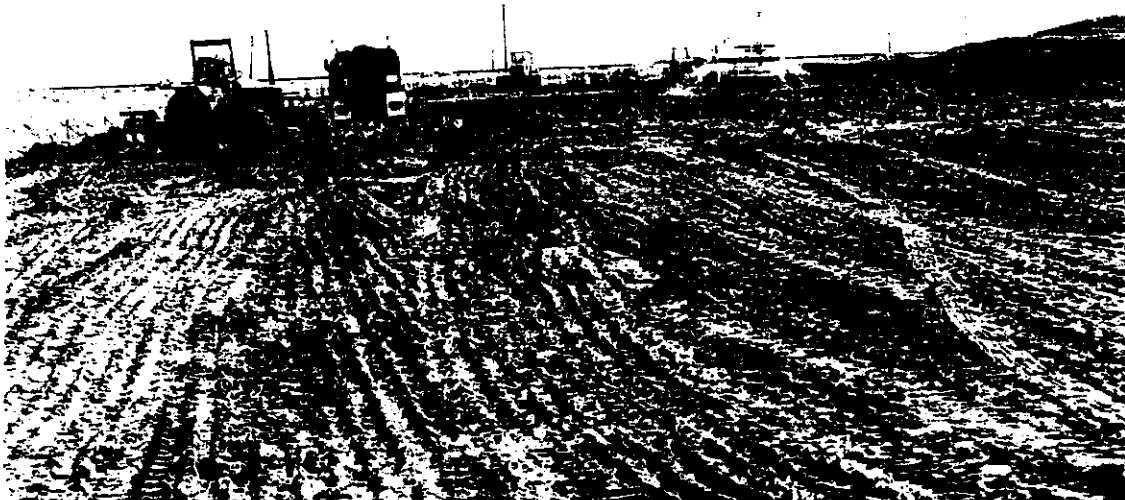
Photo 3-7. Applying Water and Disking Clay Soil to Obtain Optimum Moisture

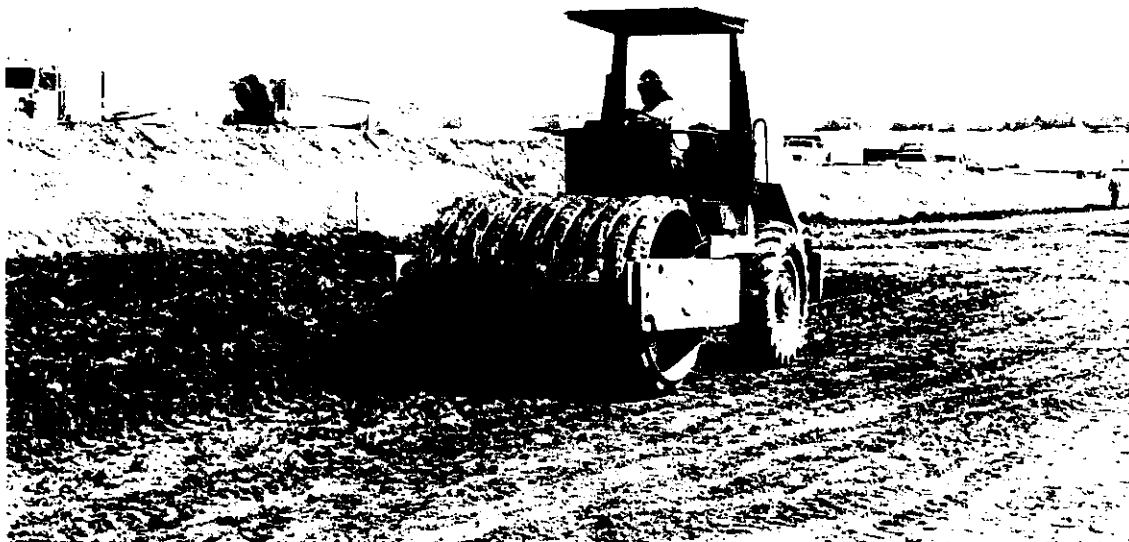
Photo 3-9. Re-Compaction of the Clay Liner

Moisture and compaction testing was conducted during liner construction to demonstrate compliance with RD construction specifications. In one area, where the moisture was outside the optimum range, the liner was ripped as shown in Photo 3-8. Additional moisture was applied using the water truck and the clay was recompacted using a sheeps foot roller as shown in Photo 3-9.

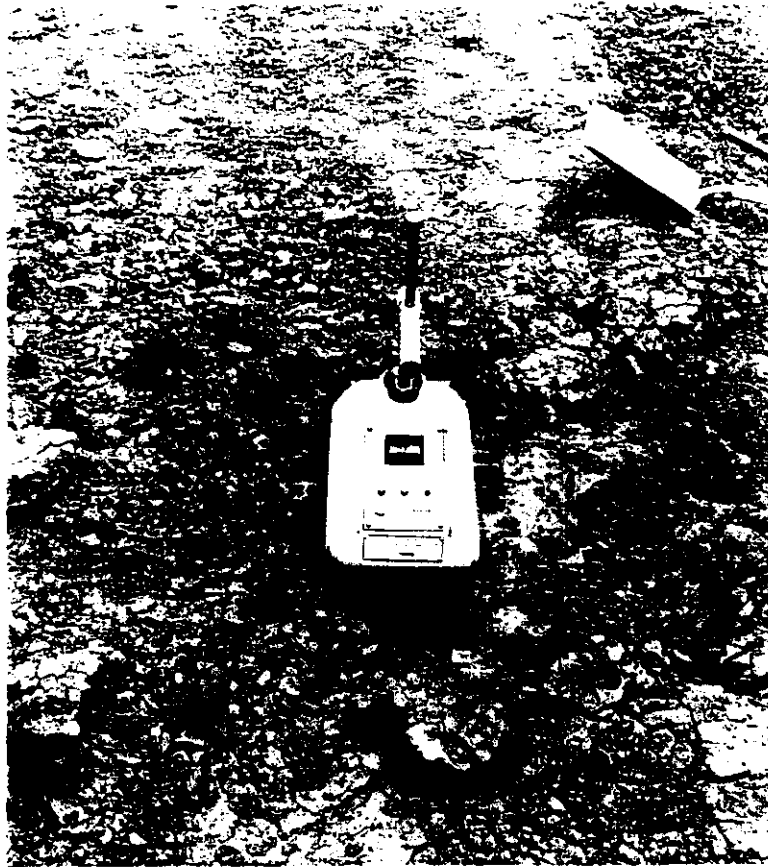
Photo 3-10. Nuclear Density Gage Test of the Clay Liner

Liner compaction requirements were confirmed using the sand cone test method (ASTM D 1556) in accordance with the RD. However, the RD did not specify the number of compaction tests and the test locations needed for confirmation. After coordination and agreement with the EPA's onsite representative, a total of 12 sand cone tests were conducted at the locations shown on Figure 3-1. The nuclear density gage method (ASTM D-2922) was an alternate test method specified in the RD. To assure sufficient compaction of the clay liner, nine nuclear density gage measurements were also taken in accordance with ASTM D-2922 at random locations over the clay liner as shown in Photo 3-10.

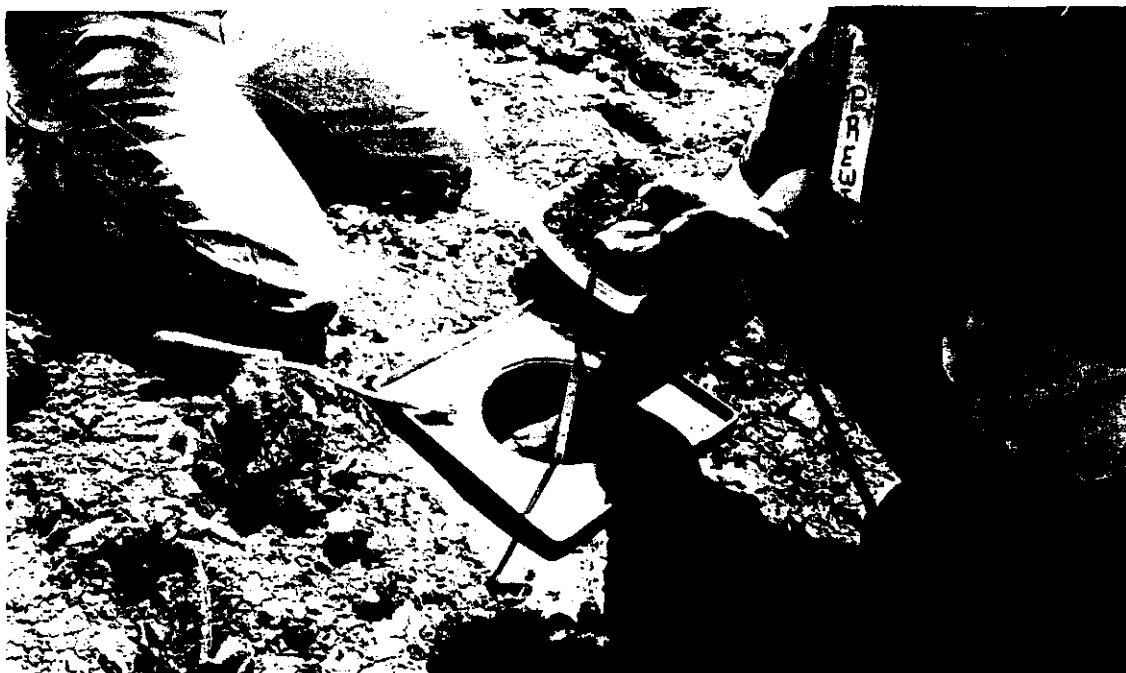
Photo 3-11. Measurement of Clay Liner Thickness at Sand Cone Test Hole

The sand cone test involves excavating a hole in the compacted clay liner. To provide additional verification of liner thickness, the thickness at each test location was measured as shown in Photo 3-11. The “in situ” dry density of the liner material was determined from the sand cone test procedure (ASTM D 1556) applied in the field as shown in Photo 3-12.

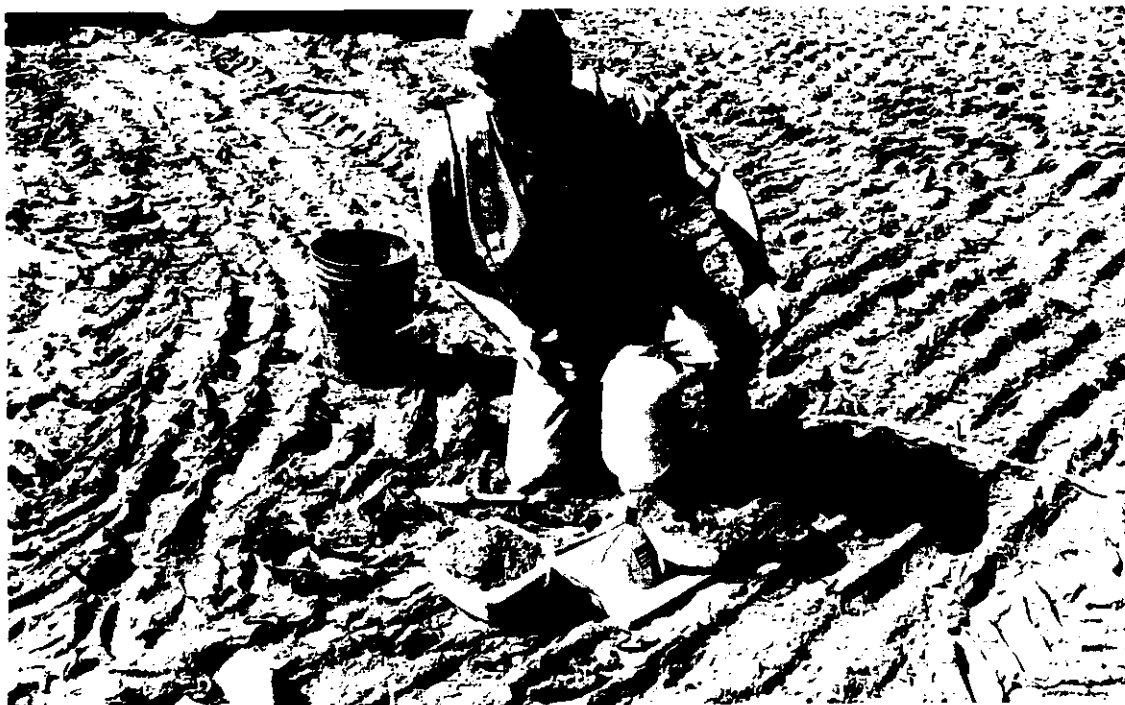
Photo 3-12. Sand Cone Compaction Test of Clay Liner

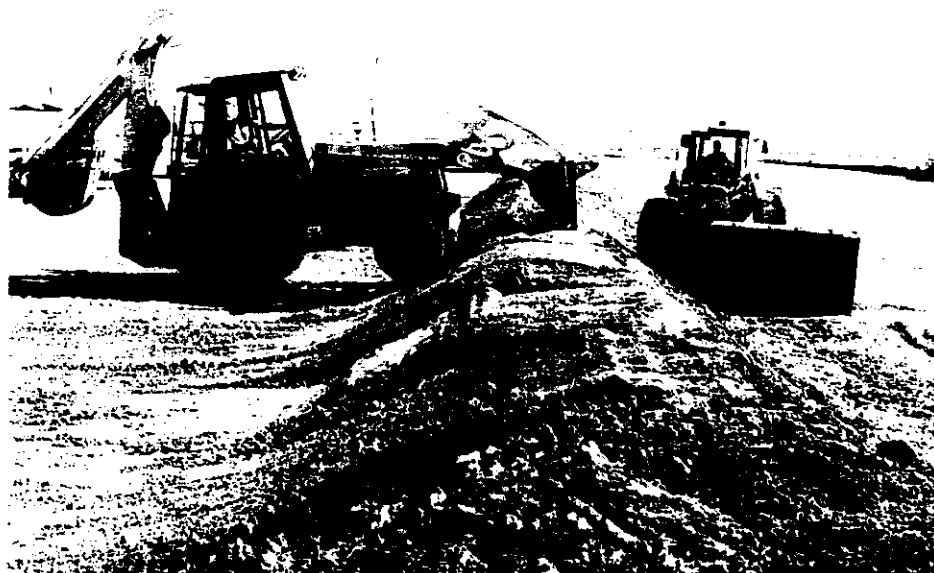
Photo 3-13. Construction of Run-on/Run-off Protection Berm

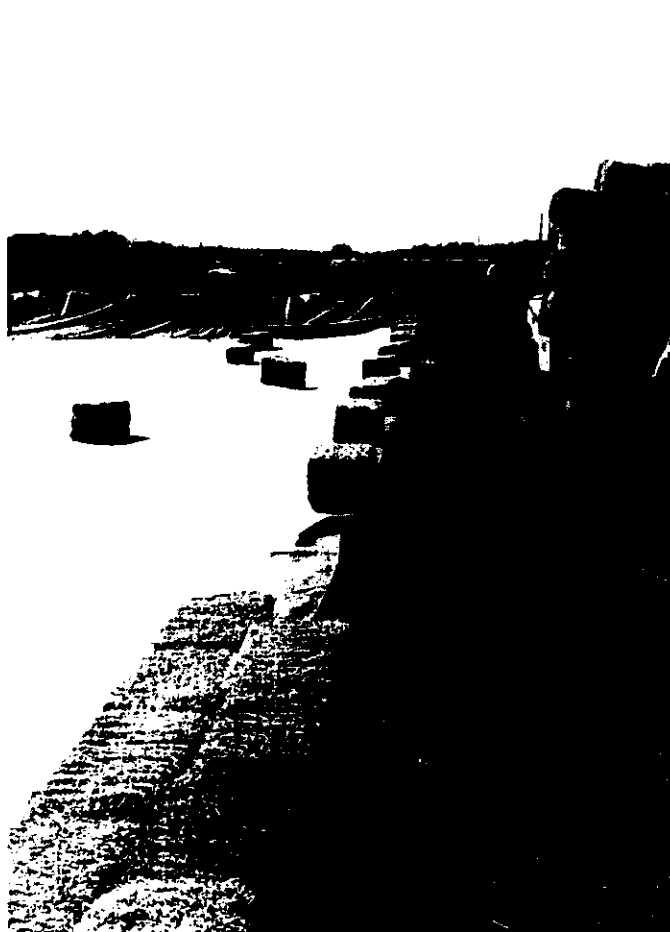
Photo 3-15. Hay Berm Installation at Toe of Landfarm Treatment Cell

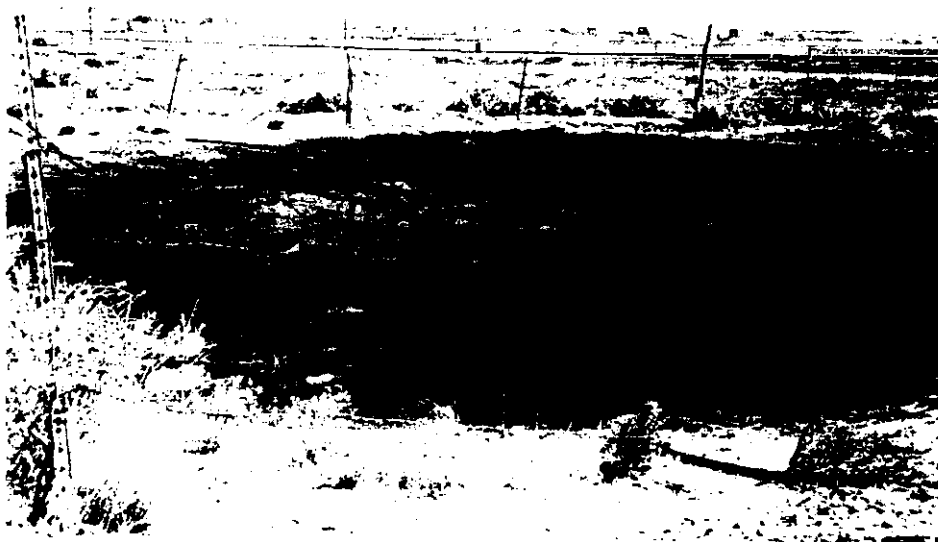
Photo 4-1. The Fence Pit Prior to Excavation

During the RI, the locations and volumes of hydrocarbon contaminated soils were determined from historical and recent aerial photographs, site inspections, and soil chemical data from sampling. The hydrocarbon soils in the Separator Area and Office Area were excavated during previous RA activities conducted during 1995 as described in Chapter 2. The remaining hydrocarbon-contaminated soils identified in the RI and RD were field located in March and April of 1996 prior to the start of excavation. The West Pits were readily identified in the field and the perimeter of each pit was evident from the pit berms as shown for the Fence Pit in Photo 4-1.

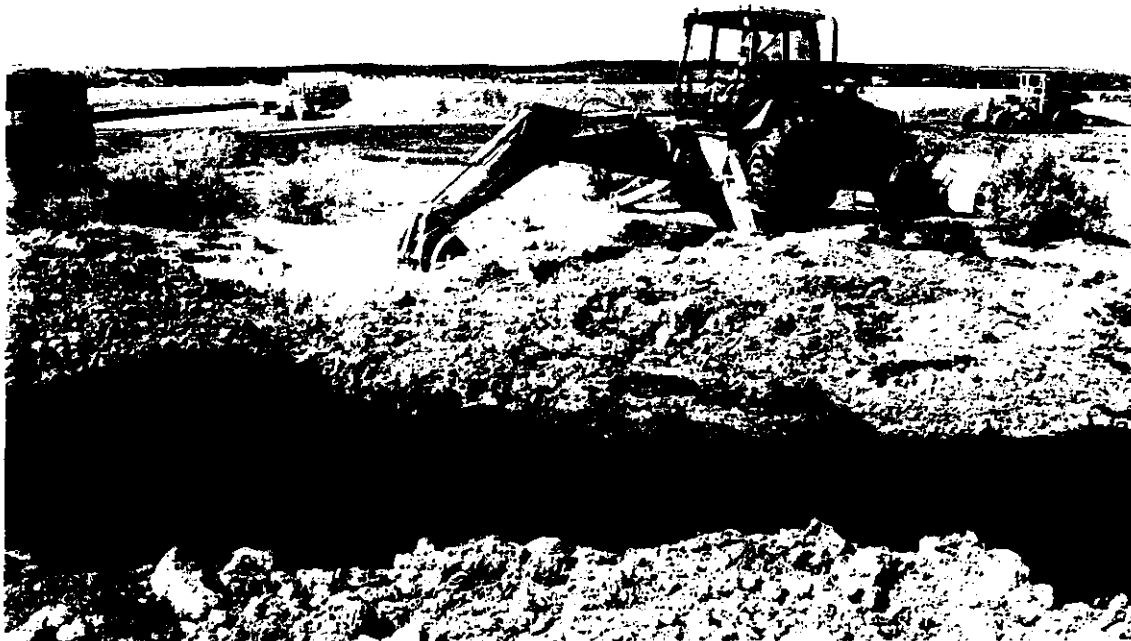
Photo 4-2. Excavation of The Fence Pit

Hydrocarbon-contaminated soils in all the West Pits locations were initially excavated to the target depth of two feet. The Fence Pit, the A Pit, and one location in the S Pit were excavated to a depth of four feet because hydrocarbon sludge was found at depths below two feet. Drill cuttings and dry hydrocarbon soil from the landfarm construction were blended with wastes in the Fence Pit, prior to and during excavation, to adsorb water and oil which helped facilitate excavation with a track hoe as shown in Photo 4-2. This also helped in the subsequent stage of soil homogenization.

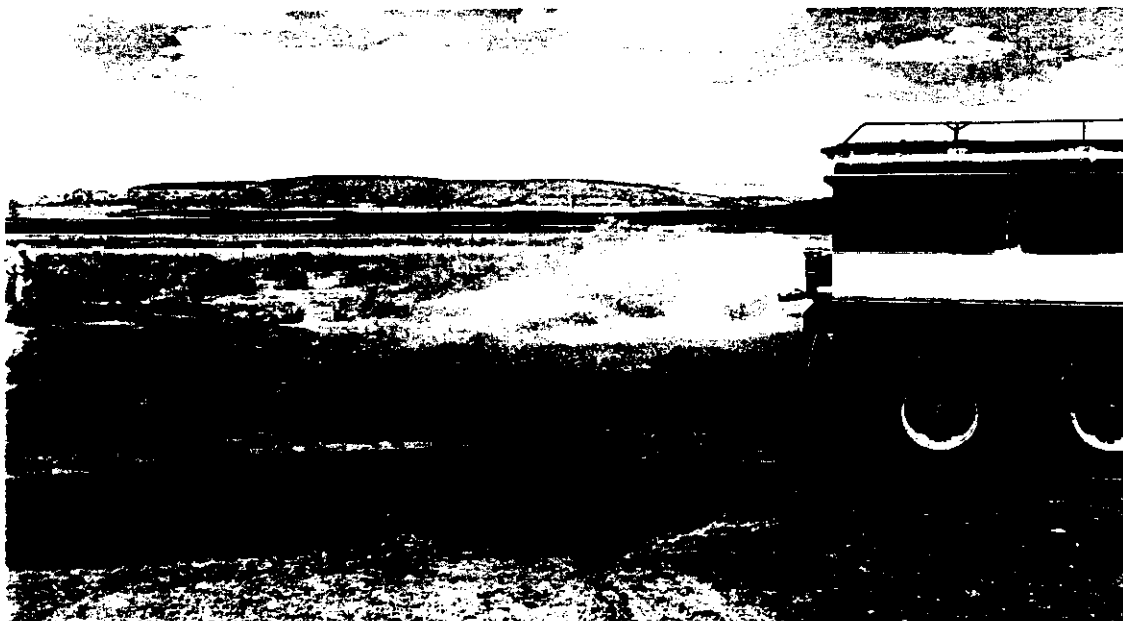
Photo 4-3. Water Spraying for Dust Control During Excavation of West Pits

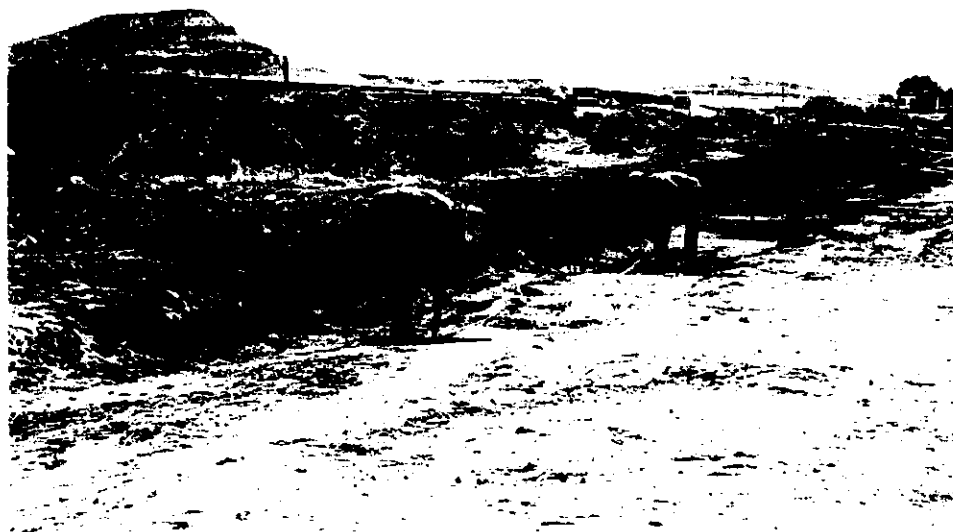
Photo 4-4. Confirmatory Sampling of Hydrocarbon Soil Excavation in Railroad Area

Excavations in the Railroad Area and associated confirmatory sampling locations are also shown in Figure 4-1. Composite samples RR-CS1 through RR-CS6 were taken following excavation of more than two feet of soil from these hydrocarbon soil excavations as shown in Photo 4-4. The calculated total benzo(a)pyrene equivalent from confirmatory sampling in the excavations of greater than two feet in depth in the Railroad Area ranged from 0.43 (all concentrations less than detection) to 9.83 ppm. These results confirm that the excavation of hydrocarbon soil in the Railroad Area met the 20.3 ppm total benzo(a)pyrene equivalent clean-up criteria.

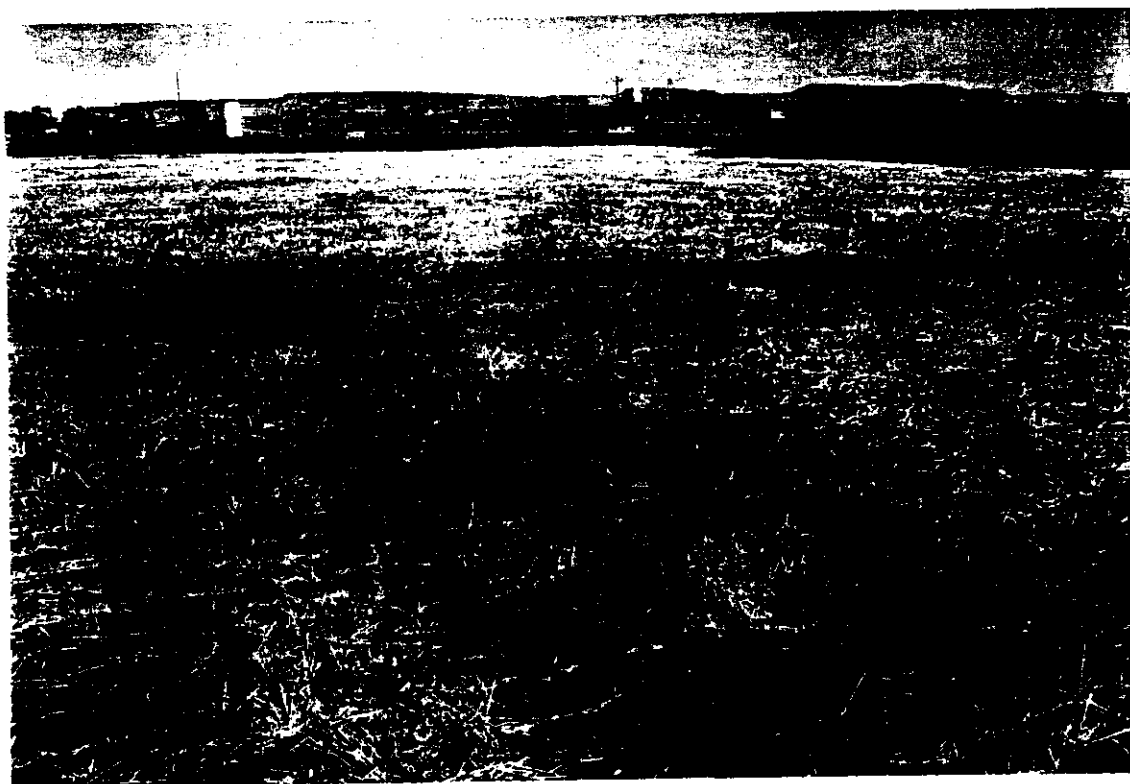
Photo 4-5. Final Backfill of Fence Pit Excavation in West Pits Area

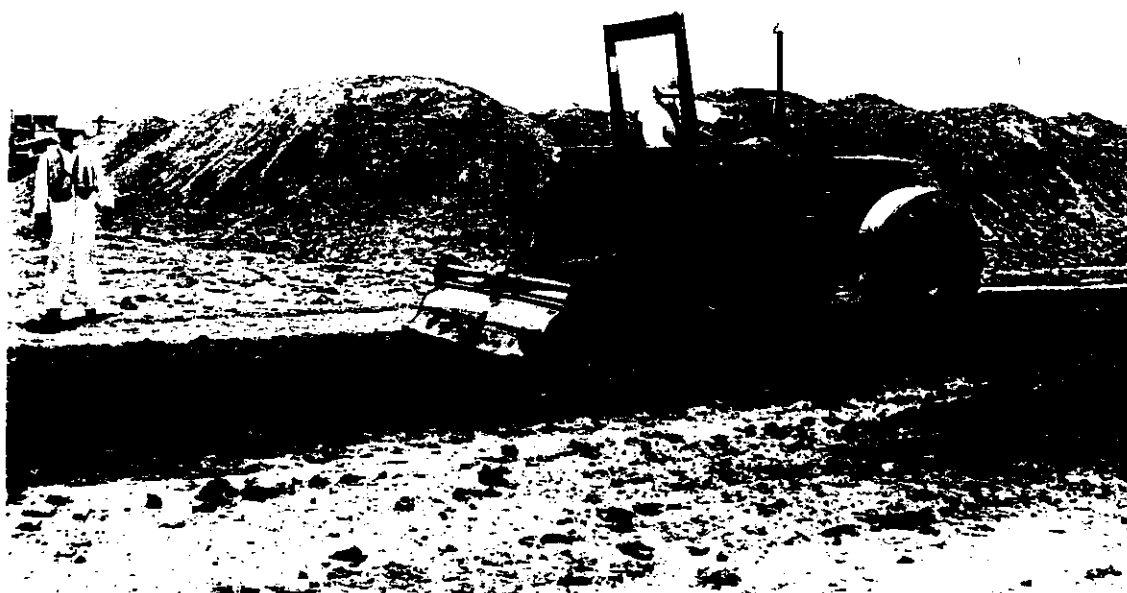
Photo 5-1. Soil Homogenization Using Disc with Homogenized Soil Stockpiles in Background

Soil homogenization was conducted in batches at a soil preparation area. The excavated hydrocarbon soils and the West Pits contents were dozed into a preparation bed to a depth of about 6 to 8 inches. The soils and wastes were homogenized using disc and rotor-tillers as shown in Photo 5-1. Rocks, pipe and construction debris were removed by hand or by dozing during soil homogenization. The soil preparation locations are shown on Figure 5-1. The soil preparation areas were located adjacent to the homogenized soil stockpiles. The soil preparation areas and homogenized soil stockpiles were located near but outside of the West Pits excavations. The dimensions of the homogenized soil stockpiles and preparation areas were restricted to as small an area as was practicable in order to reduce the volume of later surface soil removal required beneath the soil preparation and soil stockpiling locations.

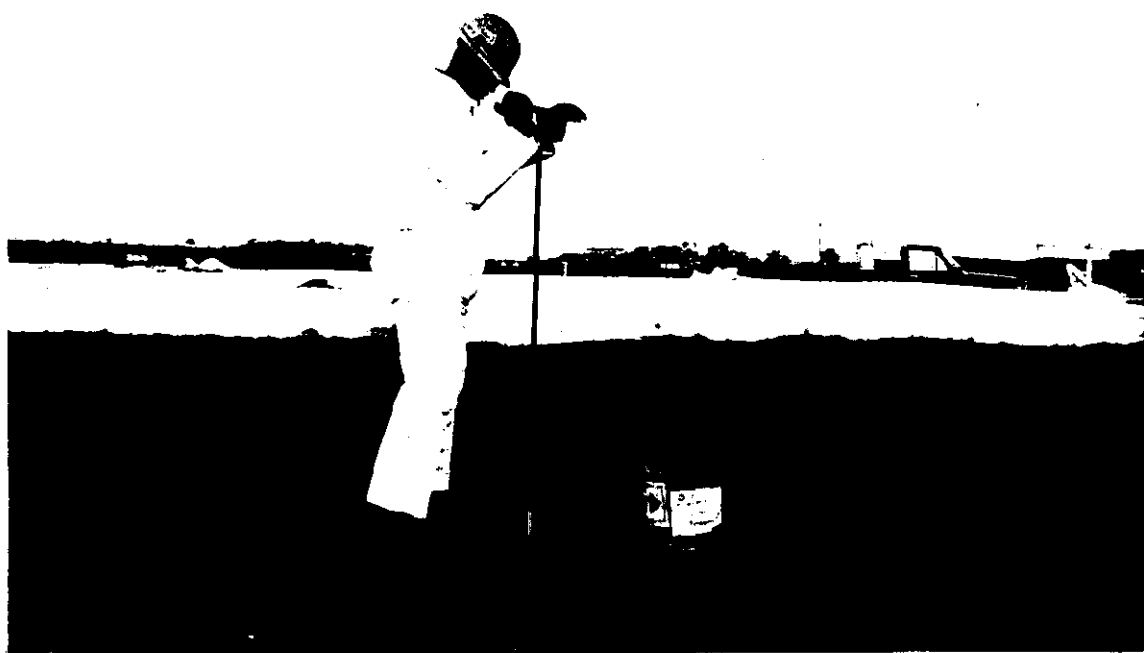
Photo 7-2. Driving Hand Auger into the Landfarm Soil for Sample Collection

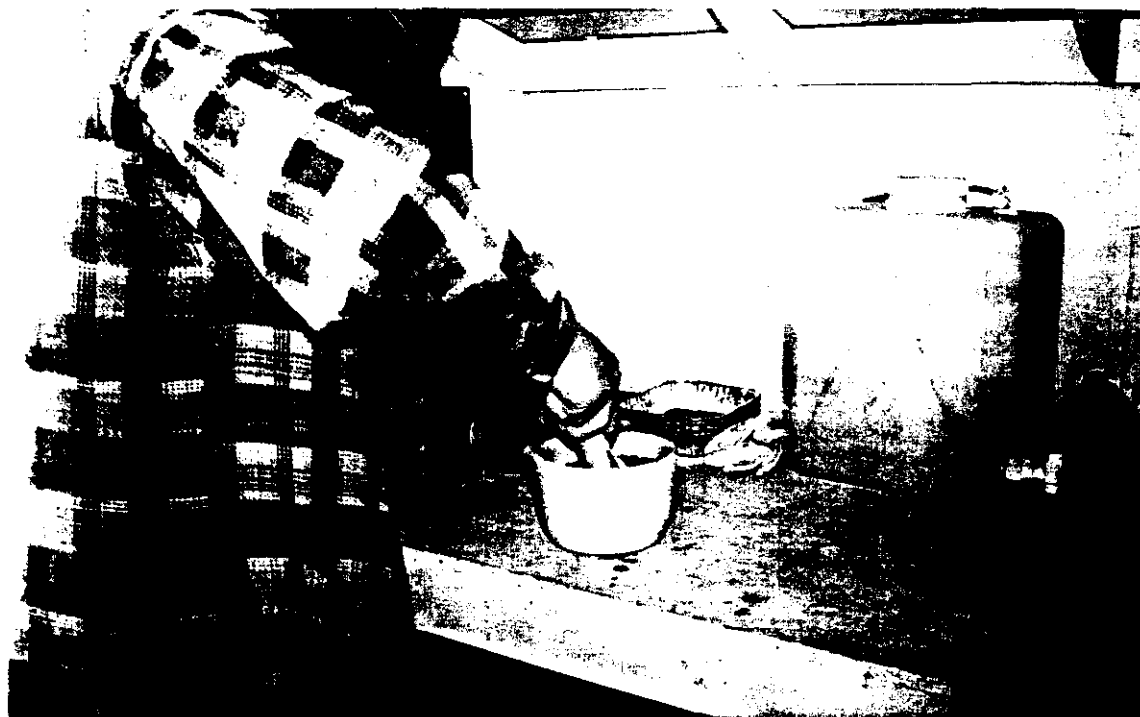
Photo 7-6. Soil Sample Screening Through 10 Mesh Sieve During Sample Preparation

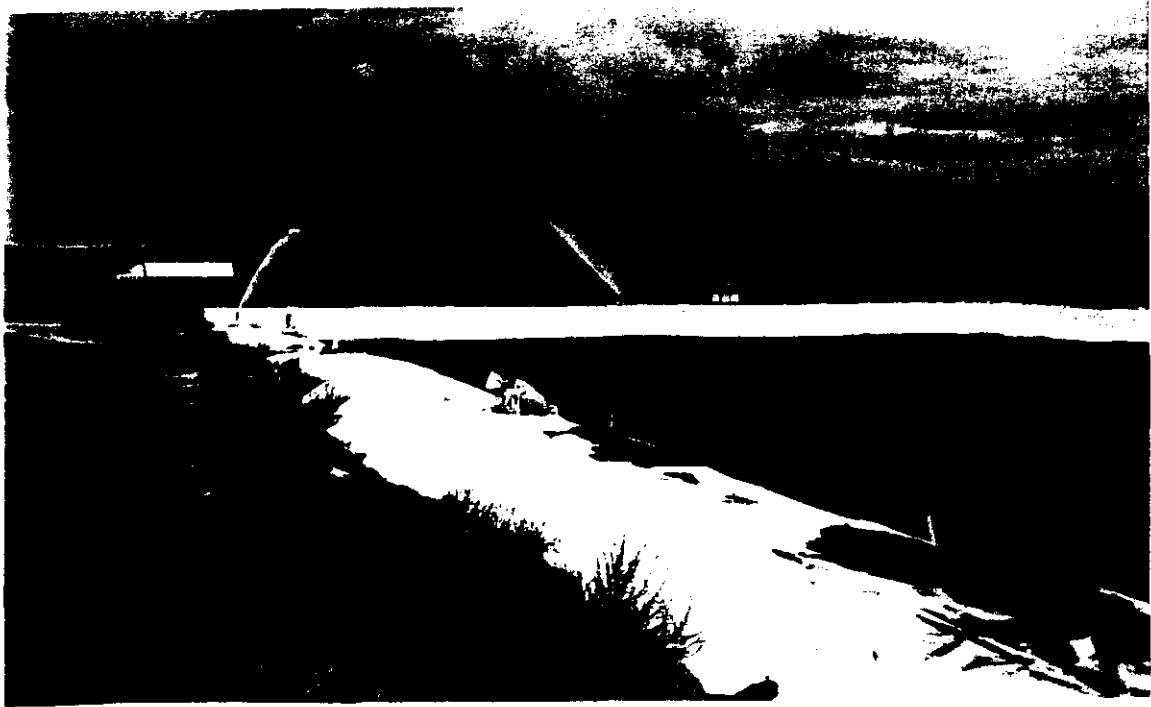
Photo 7-7. Landfarm Irrigation Sprinkler System

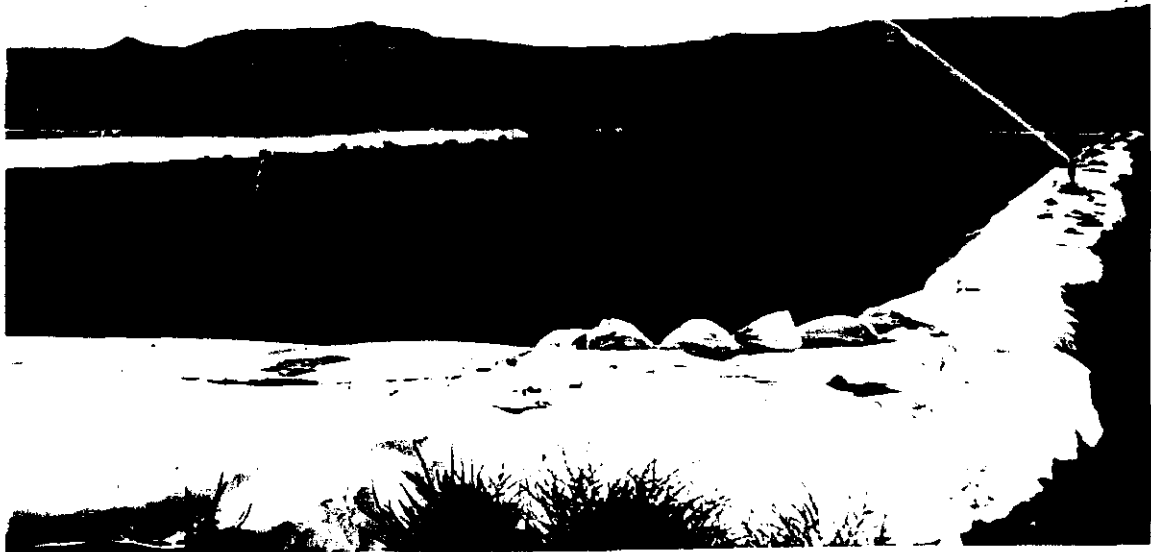
Photo 7-8. Landfarm Irrigation Sprinkler System

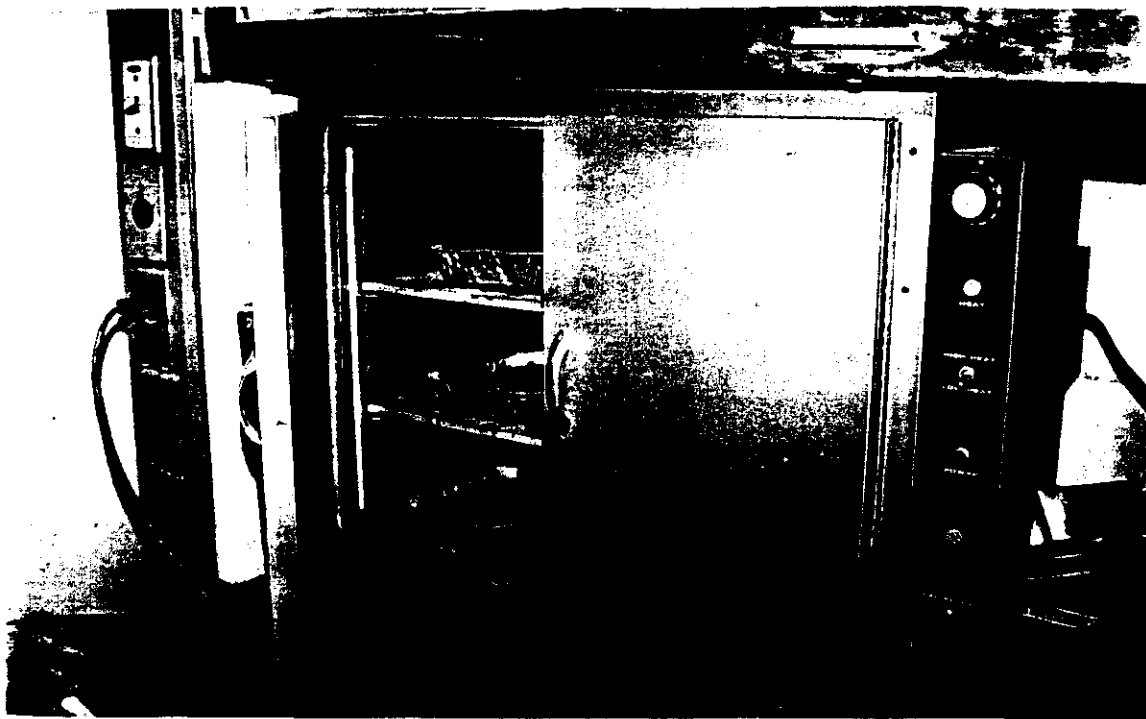
Photo 7-10. Landfarm Moisture Sample Drying

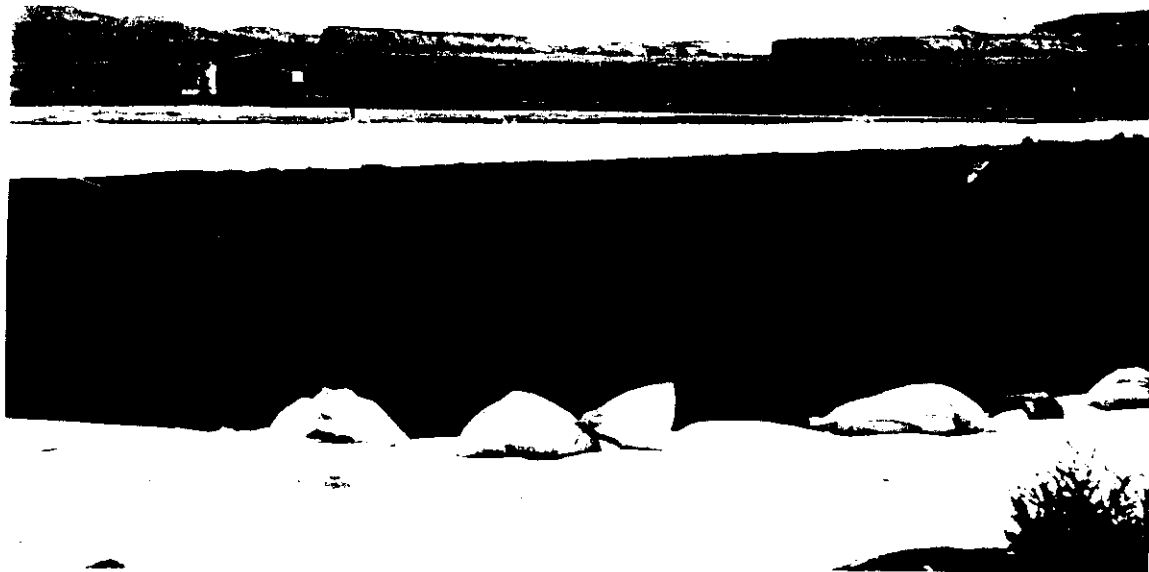
Photo 7-11. Landfarm Portable Sprinklers

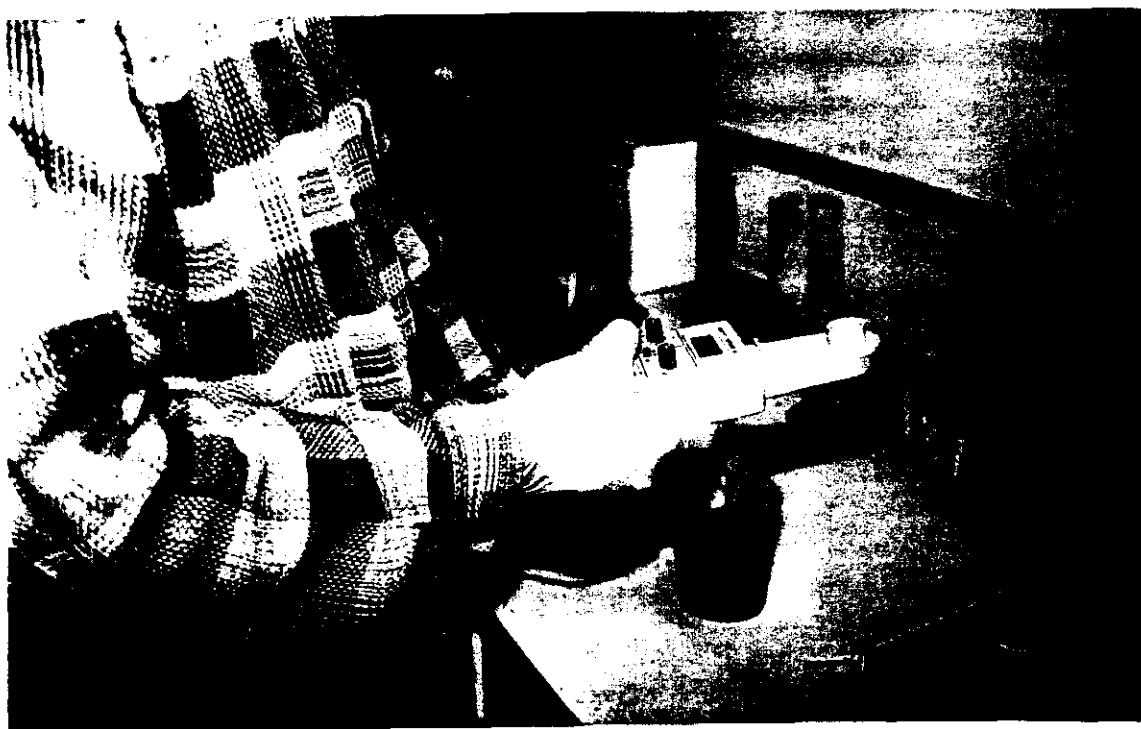
Photo 7-16. pH Measurement of Landfarm Soil Slurry

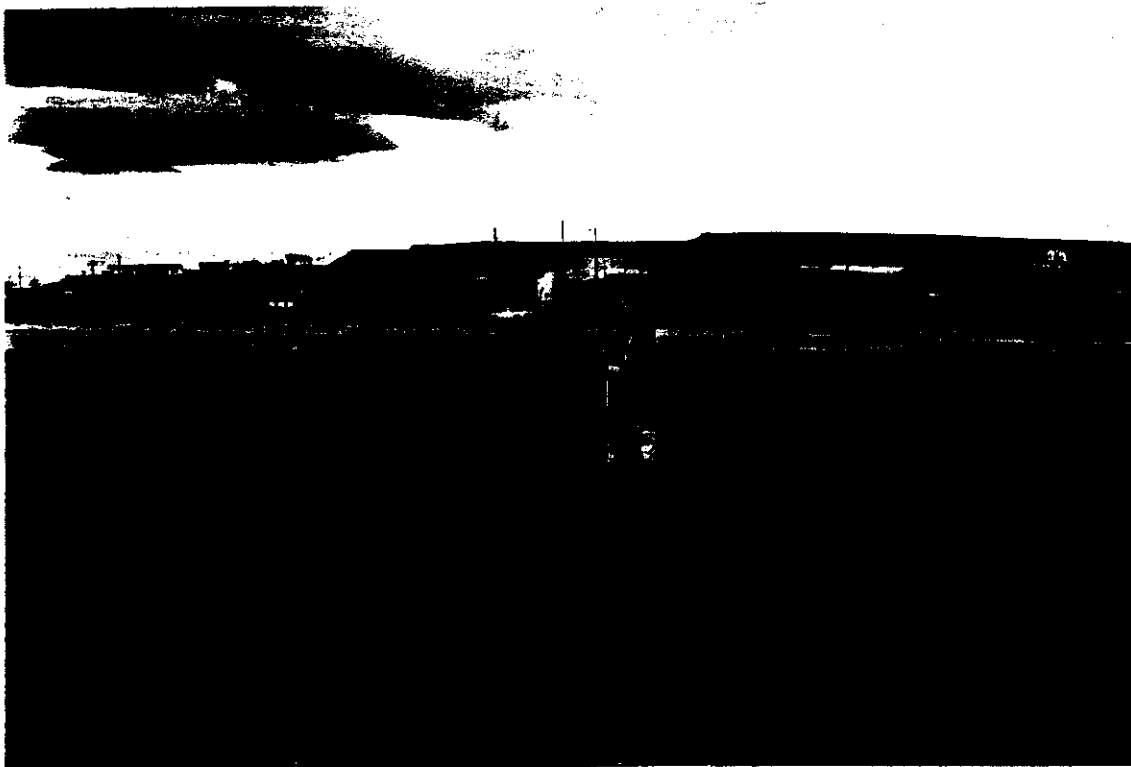
Photo 8-4. Final Elevation Surveying

A final elevation survey was conducted on November 22, 1996 after completion of the cap placement and grading. Photo 8-4 shows the final graded surface and surveying activity. The survey results, included in Appendix 8.1, indicate the average cap thickness of 1.4 feet over the treated soils. This closure cap exceeds the soil and vegetative cover requirement specified in the RD Report and the ROD. The cap was constructed using a total of 5354 cu. yds. of clean soil. Approximately 500 cu. yds. of clean soils, stockpiled previously during the landfarm construction, was used for filling and grading the low areas outside the former landfarm.

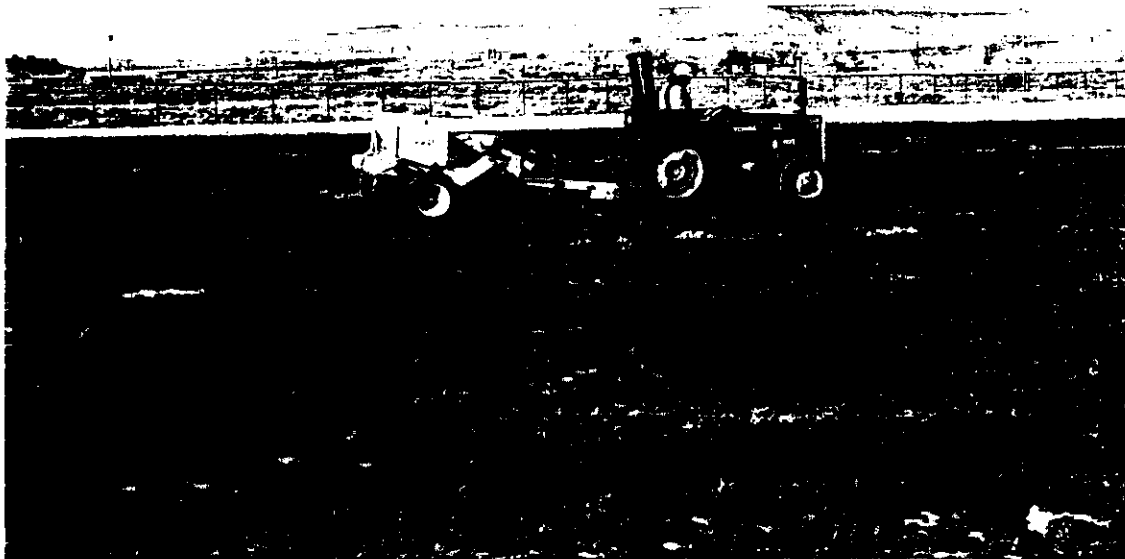
Photo 8-5. Seeding Fertilized and Disked Area Using a Seed Driller

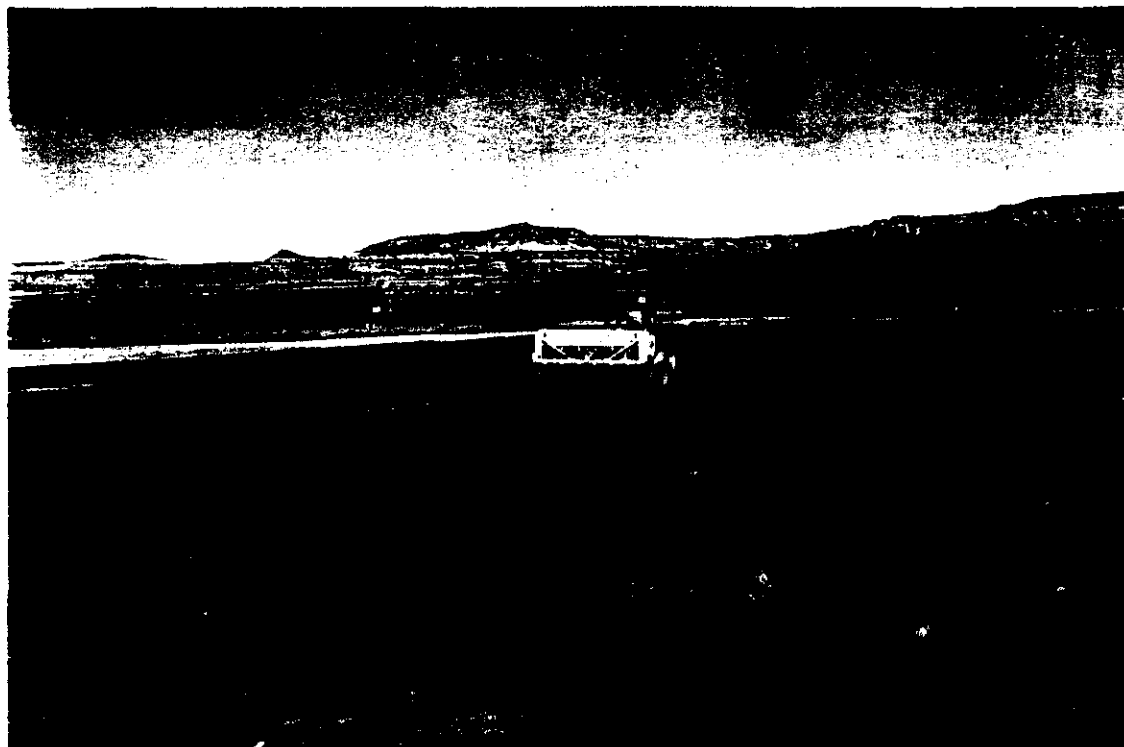
Photo 8-6. Seeding Fertilized and Disked Area Using a Seed Driller
